**A10/ Car Dyke Road Junction,
Waterbeach**

Stage 1 Road Safety Audit

Road Safety Assessment

Document Number: B0269500/01

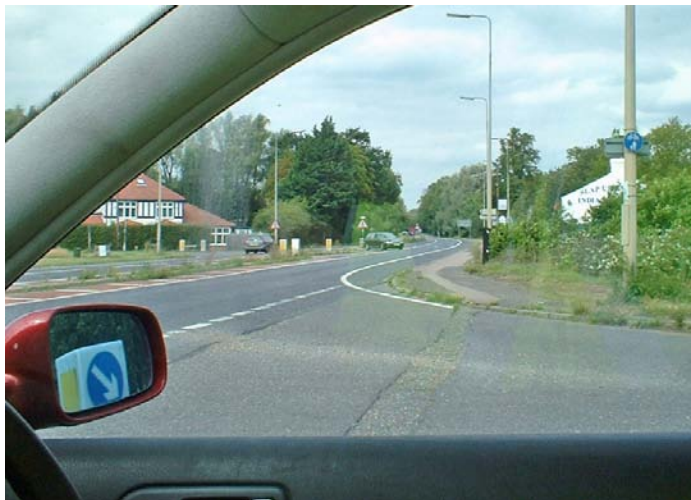
There is a wide range of collisions at this location. The most common is right-turning vehicles hitting southbound vehicles, mostly cars but also one motorcycle and this resulted in serious injury. Visibility is good (See Photo 2), so the cause is not failure to see approaching vehicles. Instead it seems to be a failure to judge the speed and position of approaching vehicles due to southbound vehicle speed. This problem would be worst at busiest times, since larger traffic volumes offer fewer gaps in traffic, leading emerging drivers to pull out into a gap which is too small for a safe manoeuvre. Queueing in the side road exacerbates such a situation, since it adds a form of peer pressure with drivers feeling they must pull out to avoid holding up other vehicles.

Photo 2: A10/ Car Dyke Road junction shows the clear visibility to the right at the A10/ Car Dyke Road junction.

The recorded rear end shunts in the side road are of a type common at such junctions where speed on the main road is fairly high, and visibility to the right is good. The driver of the second vehicle in the queue can see to the right, and may assume that the vehicle in front is going to move once the road is clear. The first vehicle driver hesitates due to the speed of approaching traffic, leading to a rear end shunt between the two.

Recommendation: At this stage, the recommended speed reduction measures on the A10 are intended to improve the turning injuries, but could also reduce rear end shunts by reducing indecision. Therefore, at this time no visibility reduction is considered necessary.

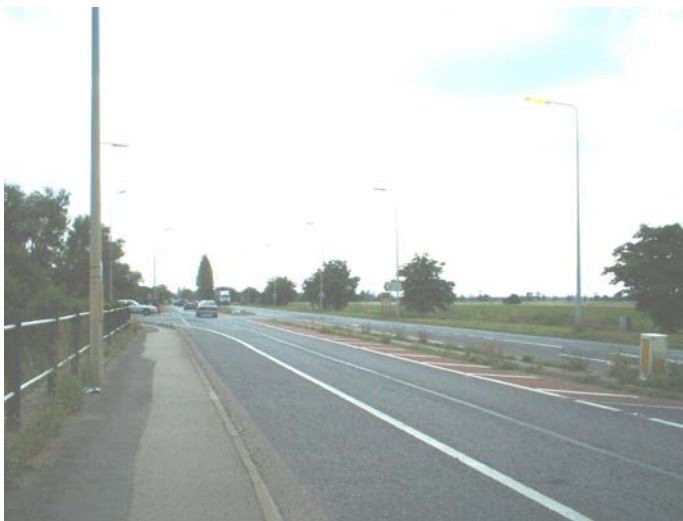
Two incidents were vehicles turning right into the junction and hitting southbound vehicles, including a motorcycle which resulted in serious injury. These incidents too are commonly associated with high speed, which makes judgement of an appropriate gap in traffic more difficult. Reduction of southbound vehicle speed can reduce this problem by giving drivers time to react.

Photo 3 below shows that southbound drivers have a clear view of oncoming traffic as it approaches and turns, so visibility is not a problem.

Photo 3: View south past Car Dyke Road junction showing the clear visibility ahead.

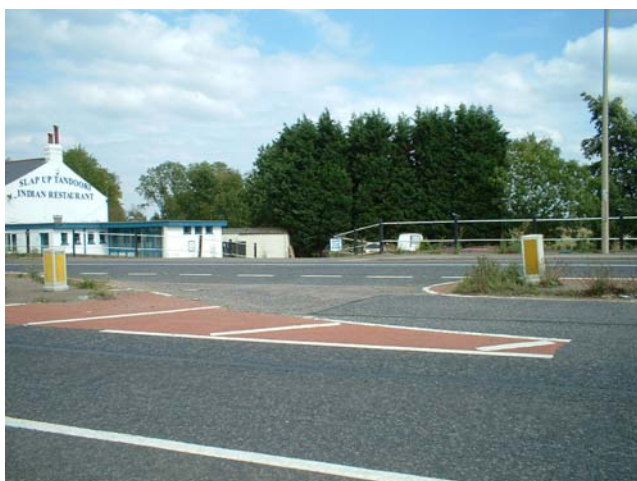
Photo 4: access to the restaurant on Car Dyke Road

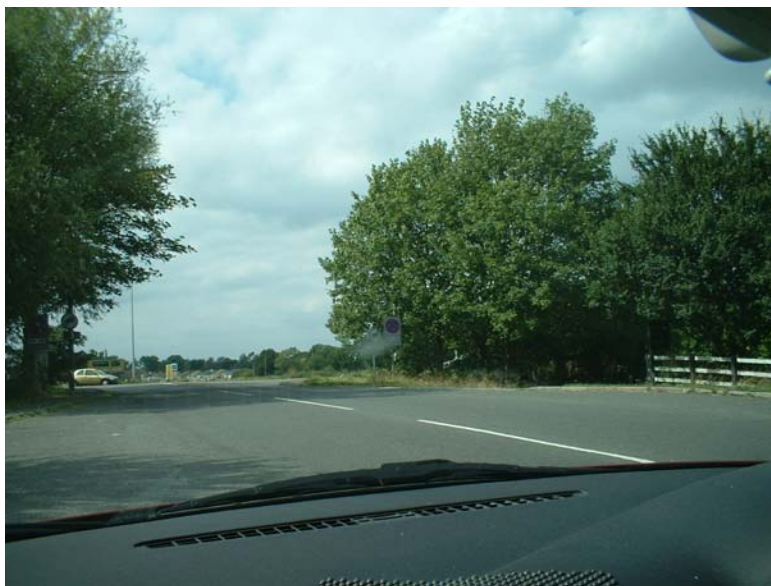
Photo 5: access to the restaurant on the A10.

Since the number of vehicles and manoeuvres entering and leaving these private accesses is currently low, and there were no recorded injuries associated with the access, it is safe to say that the proposed lakes development will not impact on the current situation greatly.

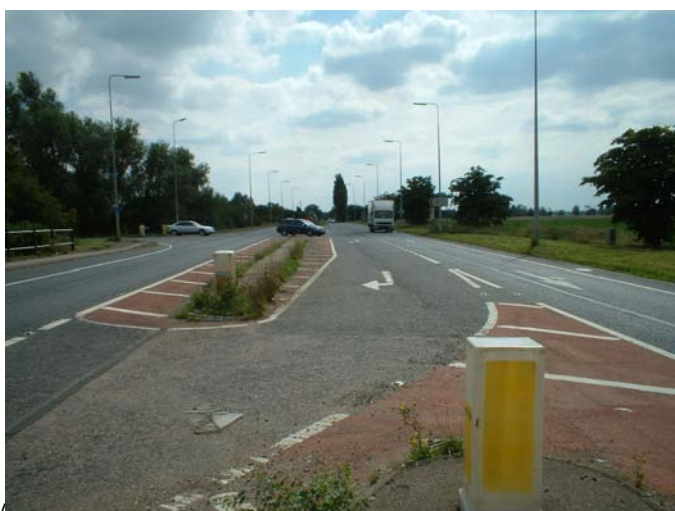
Summary: The existing lane markings are in a varied condition and the central kerbs are overgrown

Description: The existing lane markings on the A10/ Car Dyke Road junction are in a poor condition in places, the hatched areas have detritus and the lines are faded. This could reduce visibility of the lanes especially at night, and the detritus could cause a skid hazard for motor cyclists. The current kerbed central reservation islands are overgrown. This could cause poor visibility of the central reservation kerbs, especially at night. See Photo 6:

Recommendation: Ensure that lane and hatch markings are refreshed and central kerbs are maintained and ensure that a programme of future maintenance is put in place.

Remarking the lanes and hatching on A10 junction with Car Dyke Road; clearing detritus and maintaining the overgrown central kerbs is also proposed. This is would improve the visibility of the layout, and in the event of an error, reduce the risk of skidding, especially to motorcyclists who are over-represented in collisions in the area.
