**Cambridge Sport Lakes**

**Ecology and Nature  
Conservation Chapter  
Annex F: Aquatic  
Invertebrates Survey**

**September 2004**

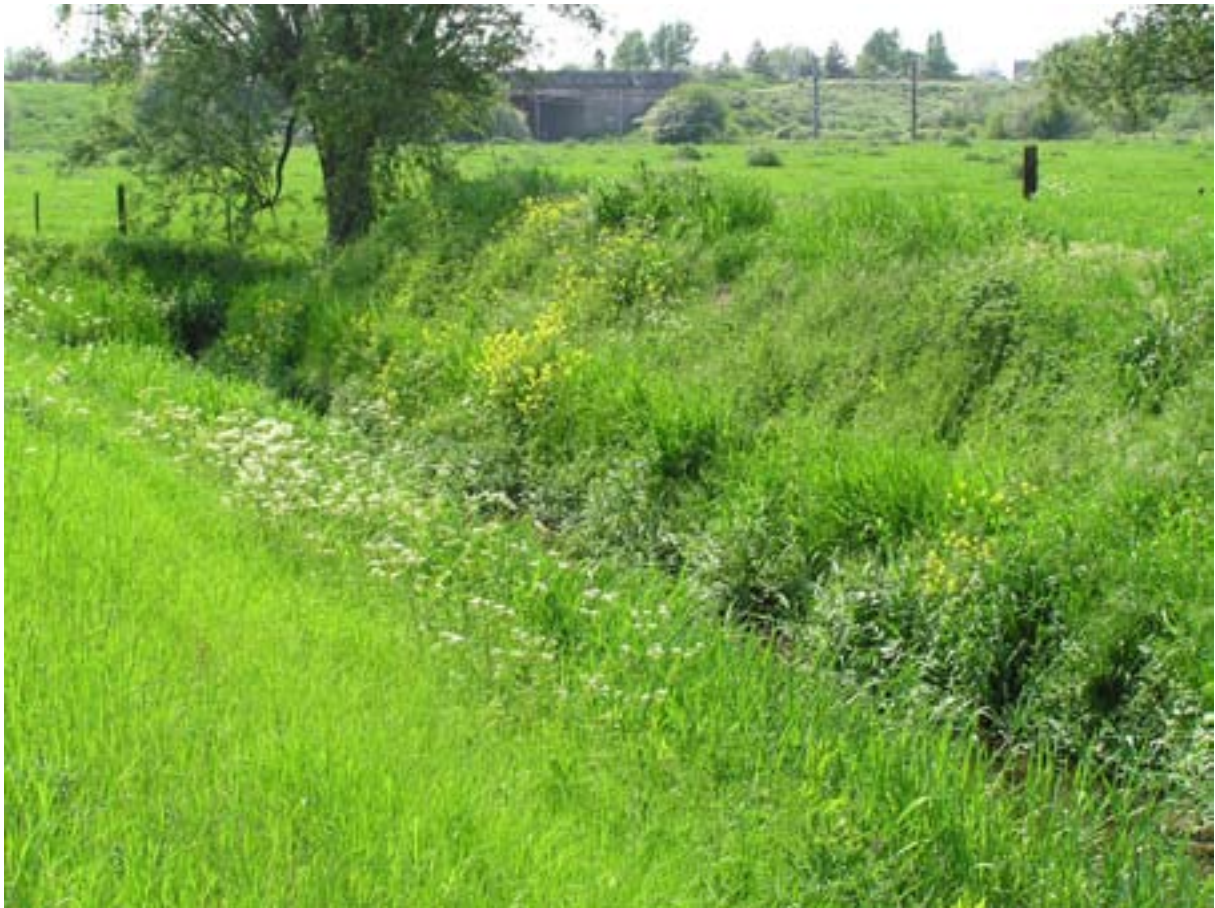
### **Site 1**

This site was located on a ditch running parallel to the River Cam at the southern end of the study area, close to the proposed Canal location. The channel was well-vegetated with both emergent and submerged vegetation and steep banks.

Average width : 1.5 – 2.0 m

Average depth : 0.5 m

Substrate composition : 100% silt

Discharge : Slow

This site was located at the southern end of the study area, on a well-vegetated ditch running parallel to the River Cam. Both BMWP score and ASPT were very low, indicating poor water quality. The invertebrate community composition reflected the slow-flowing nature of the site and was dominated by snail species. Certain species (for example the snail *Valvata piscinalis* and the damselfly *Coenagrion* sp.) were found at this site but not at any of the other sites sampled, possibly reflecting a closer link with the River Cam.

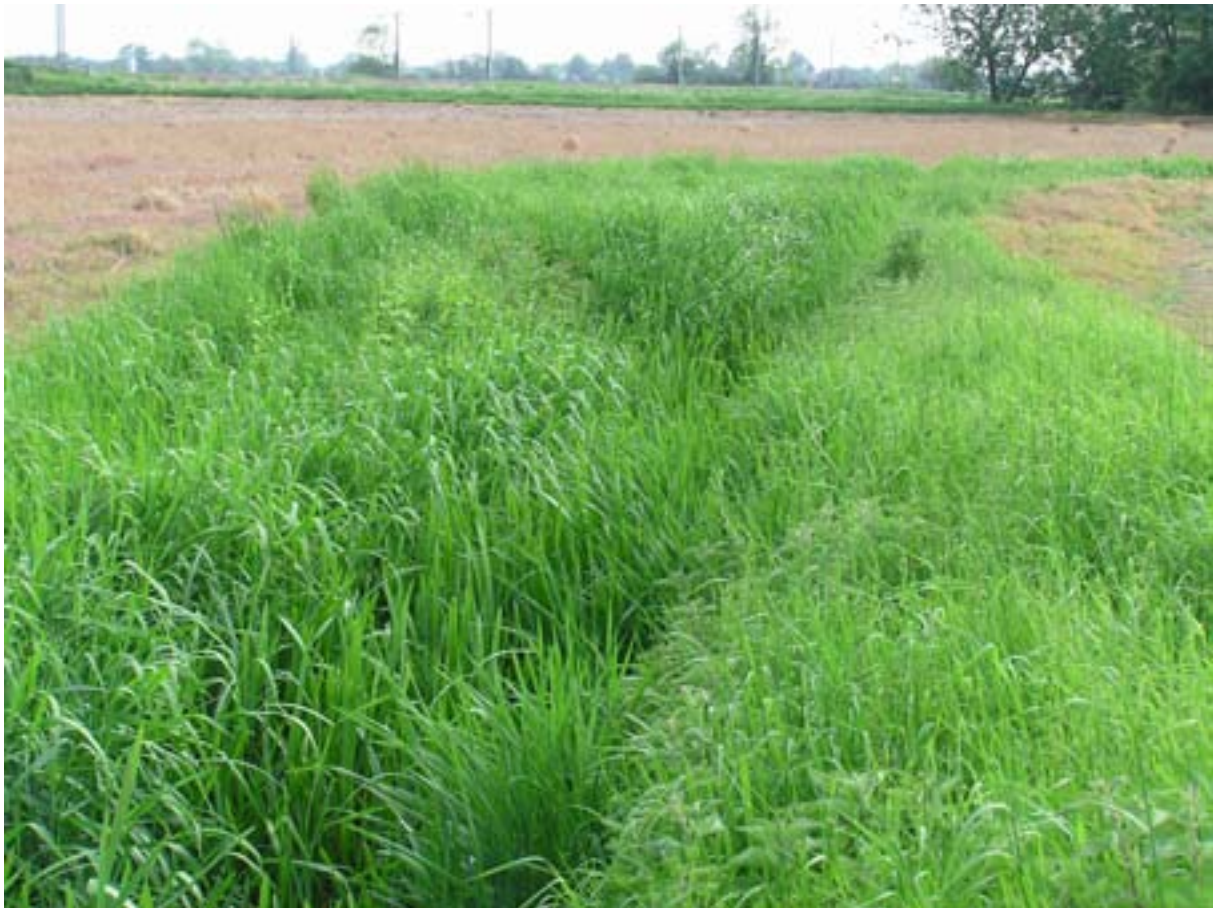
## Site 2

This site was located on a meandering ditch in the southern half of the study area. The ditch was well-vegetated with emergent vegetation and steep banks.

Average width : 1.0 m

Average depth : 0.6 m

Substrate composition : 100% silt and decaying vegetation

This site was located on a meandering ditch in the southern half of the study area. The ditch was well-vegetated with emergent vegetation and steep banks. As for Site 1, the BMWP score was low indicating poor water quality, however the ASPT was slightly higher (although only indicating moderate water quality). As for Site 1, the community composition was fairly typical of a slow-flowing habitat although this site contained a lower diversity of snails and a higher diversity of beetles taxa.

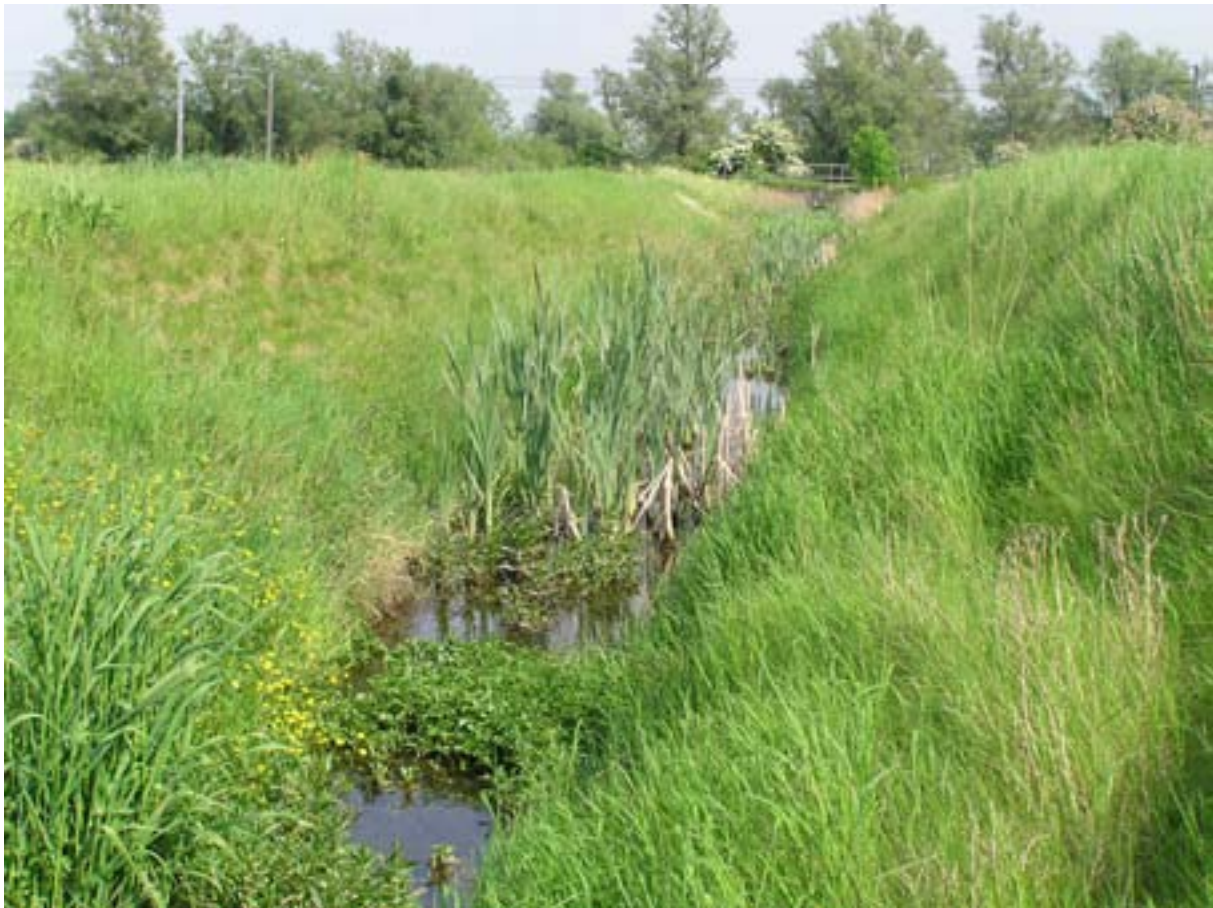
### Site 3

This site was located on a ditch at approximately the mid-point of the study area. The ditch crosses the study area in an east-west direction. The ditch was well-vegetated with emergent vegetation.

Average width : 2.5 m

Average depth : 0.5 m

Substrate composition : 100% silt

Discharge: Slow

Site 3 was located on a ditch at approximately the mid point of the study area. The ditch crosses the study area in an east-west direction. Both BMWP score (moderate water quality) and ASPT (good water quality) were the highest of all the sites sampled. As for the other sites, the community composition was fairly representative of a slow-flowing lowland system, with most taxa found having a preference for slower flows.

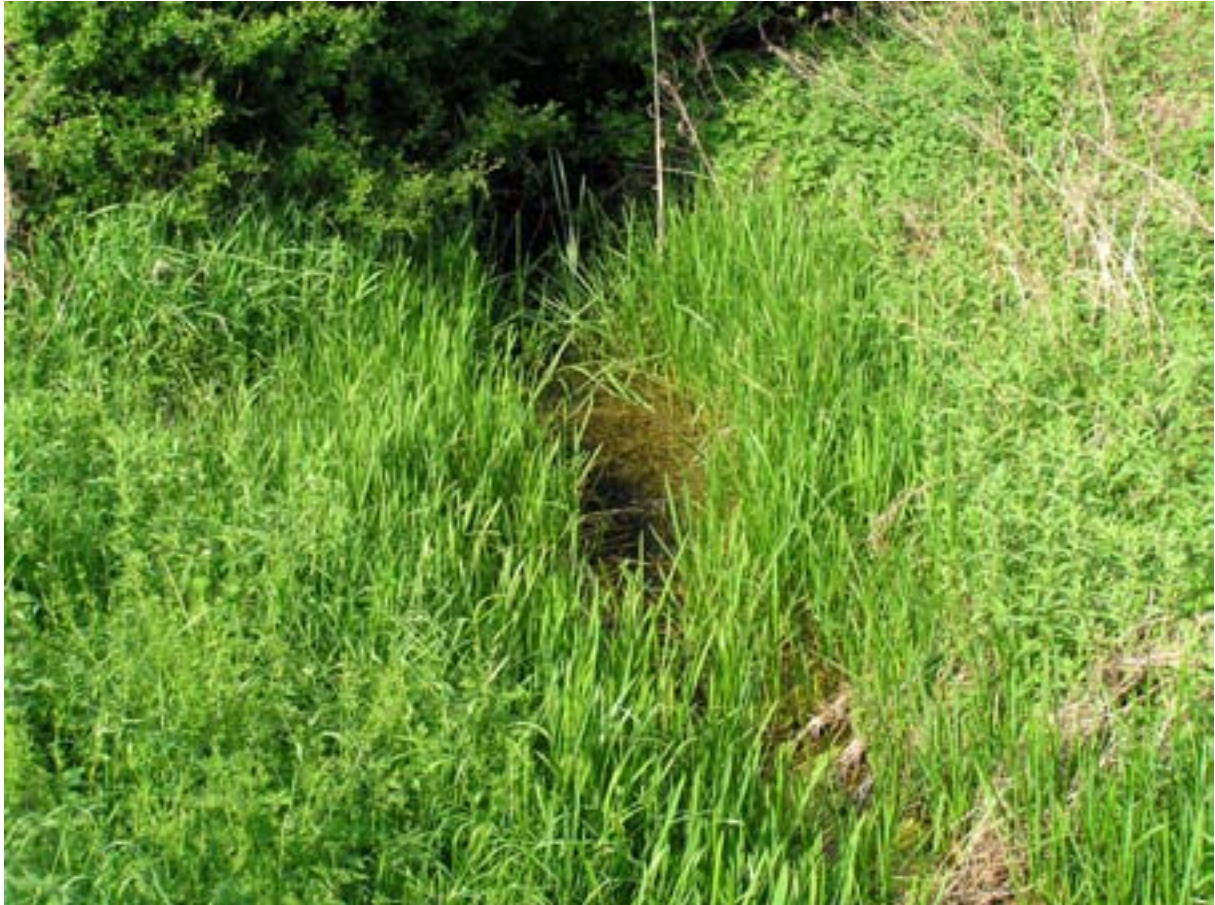
#### **Site 4**

This site was located on a ditch which runs parallel to the Cambridge / Ely railway line, at the foot of the embankment. This ditch runs almost the entire length of the study area. Site 4 was located at the northern end of the study area, close to Carr Dyke and had steep banks and extensive emergent vegetation.

Average width : 1.0 m

Average depth : 0.8 m

Substrate composition : 100 % and decaying vegetation

Discharge : Very slow

This site was located on a ditch which runs parallel to the Cambridge / Ely railway line, at the foot of the embankment. This was the longest ditch, running almost the entire length of the study area and was also sampled at another location (see Site 5 below). Site 4 was located at the northern end of the study area, close to Carr Dyke. The BMWP score was low (indicating poor water quality), while the ASPT was slightly higher (indicating moderate water quality). This site had the highest diversity of beetles of all the sites and particularly noticeable was the large number of beetle larvae of the family Helodidae, which were also found further along the same ditch at Site 5, but at no other sampling location.

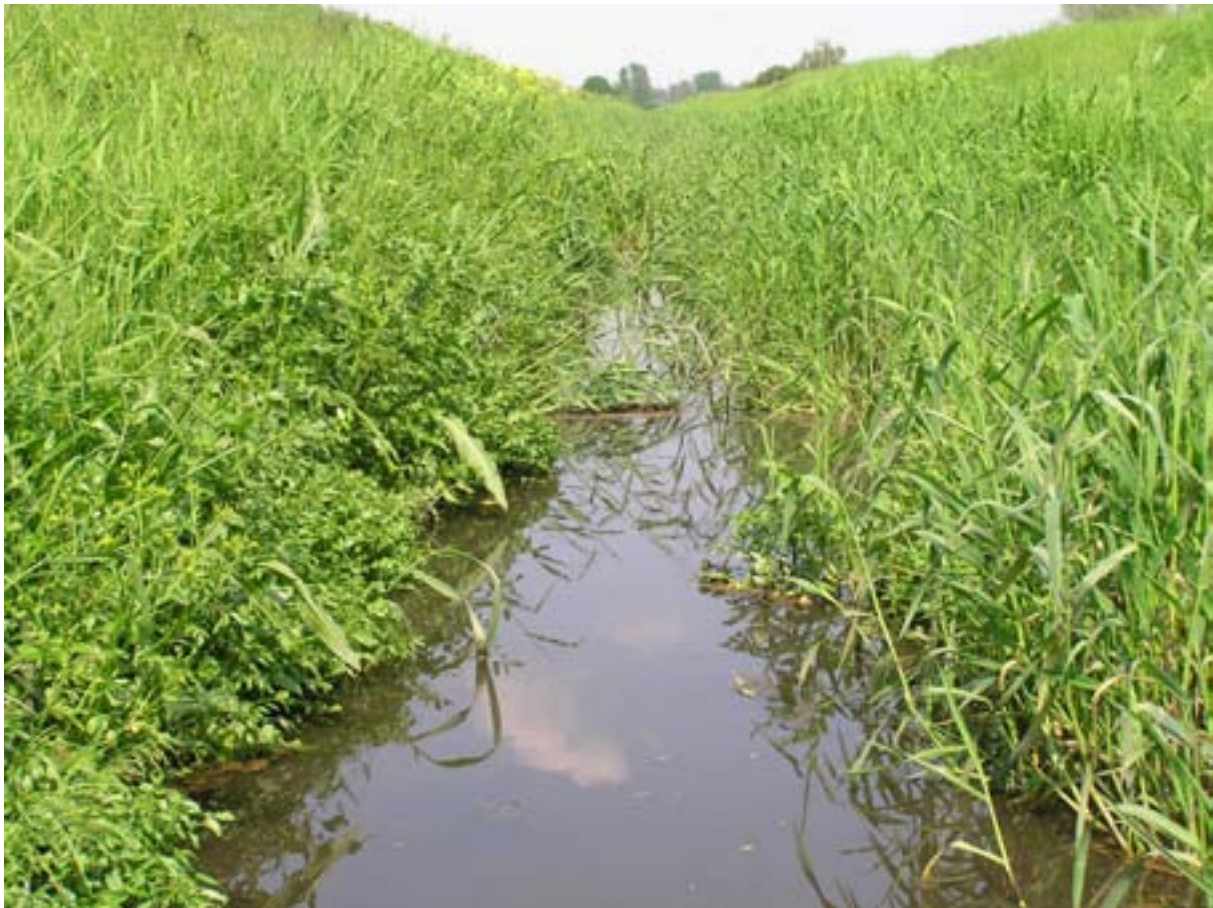
### **Site 5**

This site was located further south on the same ditch as Site 4.

Average width : 1.0 m

Average depth : 0.3 m

Substrate composition : 100% silt and decaying vegetation

Discharge : Very slow

Site 5 was located further south on the same ditch as Site 4. Both BMWP score (poor water quality) and ASPT (moderate water quality) were similar to Site 4, as was community composition.
